Cracking Problems in Wind Turbines

Javier Rodríguez[1], Francisco Riera[1], Joaquín Martí[1],
Pablo Carretero[2], and Alicia Álvarez[2]

[1]Principia, Madrid, Spain
[2]Argos, Madrid, Spain

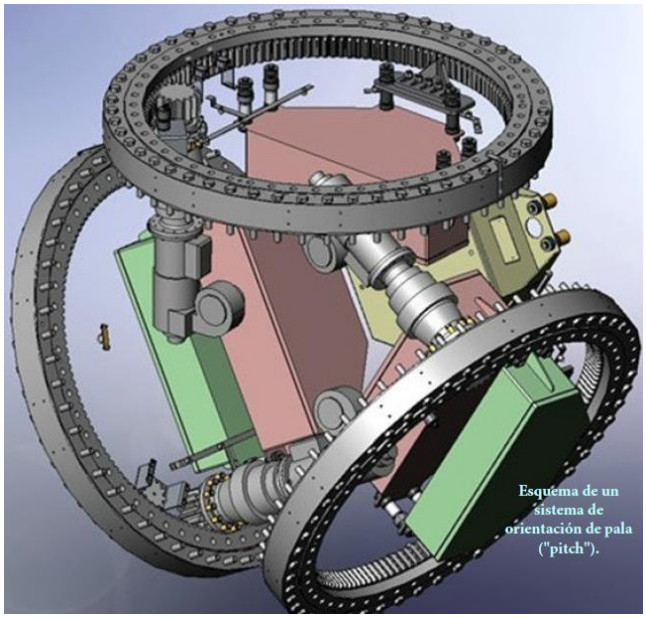
Figure 1. Pitch control system.

The aluring connects the root of the blade to the pitch control system, as schematically shown in Figure 1. It is made of aluminium 5083 and connected through 60 M20 bolts class 10.9. Figure 2 presents two views of the aluring, which has an inner radius of 440 mm and a thickness of 40 mm. At the other end it is linked to the blade with epoxy reinforced with unidirectional glass fibres (Figure 3). No structural credit is given to the fill or the outer skin, nor to the silicone used in the retrofit that will be described later.

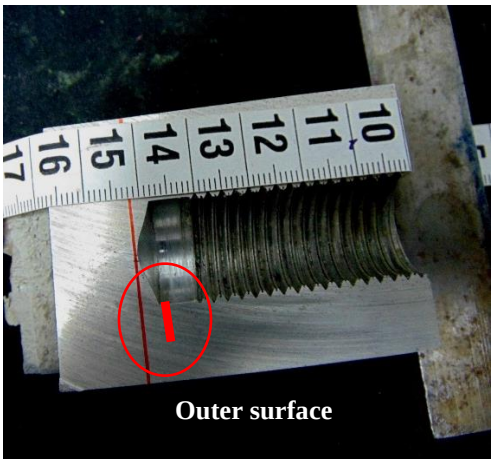
Figure 4. A bolt hole and typical location of cracks.

Figure 4 shows the countersunk end of a bolt hole. Fatigue cracks were detected around the countersinking, propagating outwards and perpendicularly to the hole axis. As they lengthen, cracks may affect more than one hole, eventually leading to the failure of the connection and the release of the blade.

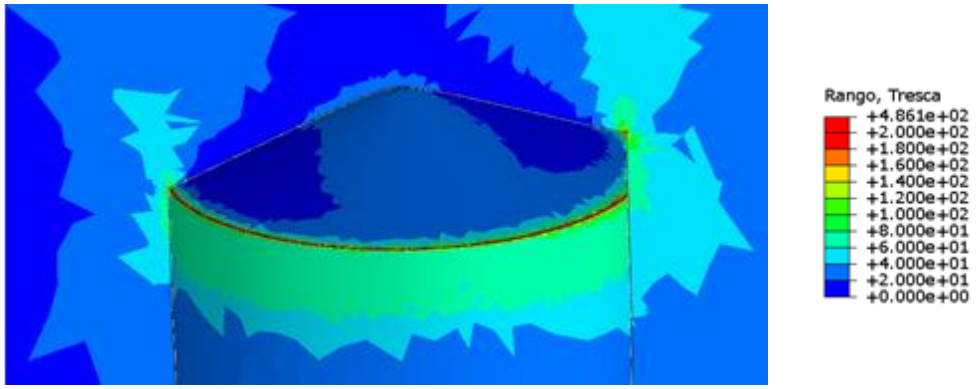
Figure 8. Range of Tresca stresses (MPa).

Figure 8 does not present stresses extrapolated to the surface, but centroid stresses; the Tresca stresses shown represent differences between the maximum and minimum principal stresses. The jumps across elements do not reflect so much stress discontinuities, but differences in centroid locations between differently oriented contiguous elements. As mentioned, the mesh was generated so that the centroids in the countersinking region are $L/2$ distant from the surface.

The maximum range observed is 486 MPa, considerably larger than the admissible 200 MPa, following the criterion of maximum shear stress (half of Tresca's value); it is therefore expected that the structure will fail before the end of its design life. This corresponds to the reference fatigue scenario, which is fairly conservative, but failure would still be expected if the stress oscillations were reduced by a factor of 2. This result is consistent with the physical observations, as is the critical location for propagation, which is the outer region of the countersinking. If the transition from the cylindrical hole to the countersinking had been smoother, probably it would have been possible to avoid such problems during the design life.

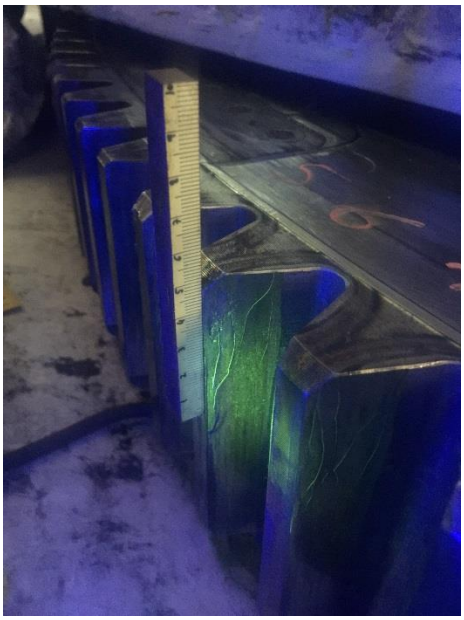
Figure 9. View of representative cracks.

Various types of cracks were detected (Figure 9). It was noticed that those starting in the face of the tooth have difficulty to propagate, but those starting in the flank may do so and eventually go fully across the tooth (Figure 10).

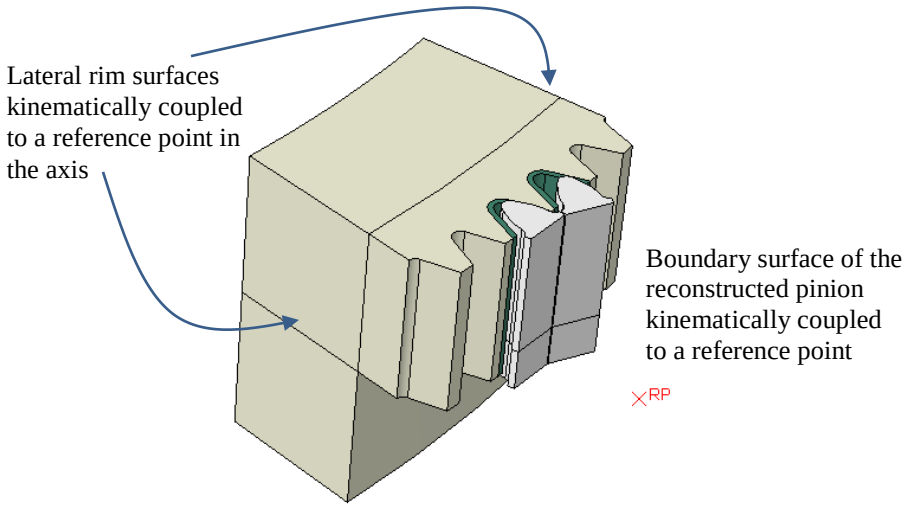
Figure 11. Geometry of the assembly.

The geometry shown in Figure 11 was reconstructed with Abaqus/CAE (SIMULIA, 2016c). The teeth evolute was generated with a 10-point spline. Based on the reconstructed geometry, Figure 12 presents views of the meshes used to model the gear rim and pinion teeth. The global mesh, including both gear and pinion, has 289,102 elements, 326,746 nodes, and 940,788 degrees of freedom. It is formed by hexahedral elements with reduced integration. The element size near the surface is 1 mm along the profile, 2 mm in the longitudinal direction, and 0.7 mm in the thickness.

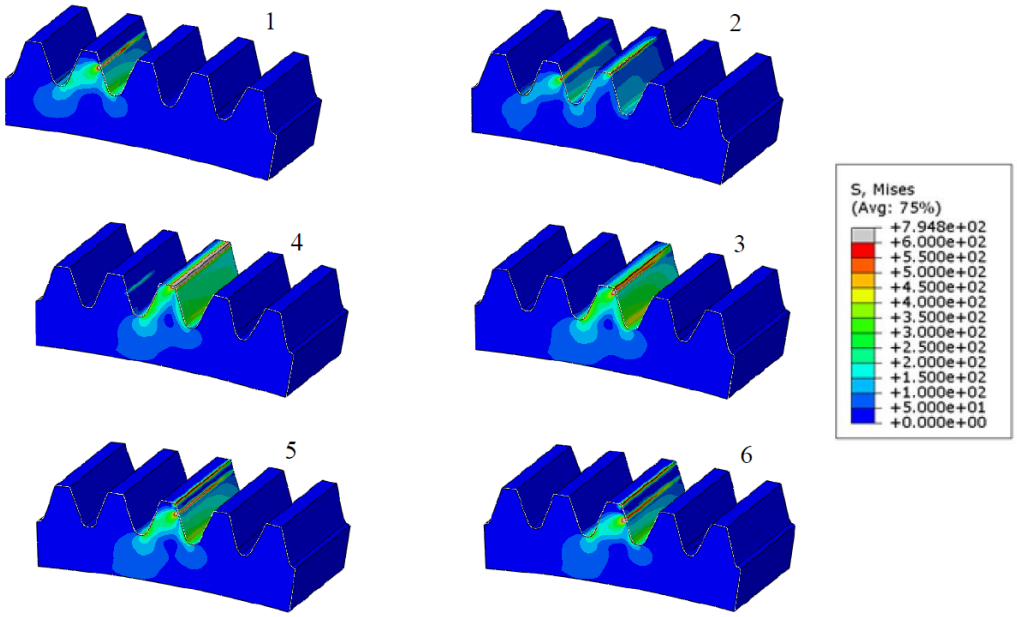
Figure 13. Stresses (MPa) at different instants for 26,1 kNm (cut at max. crowning).

Figure 13 shows the stresses at various instants. Plastic strains are localized near the top land, suggesting that the cracking experienced is a consequence of the high level of contact stresses.

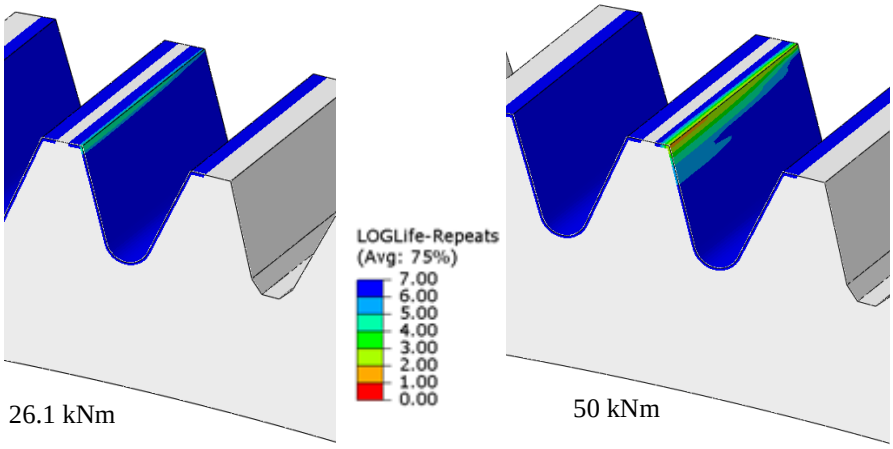
Figure 14. Fatigue life (number of cycles).

The fe-safe fatigue analyses were based on the Brown-Miller criterion, using Morrow's correction on the basis of parameters estimated by Seeger's method. As can be seen in Figure 14, only small cracks are expected after 10,000 load cycles near the top land.

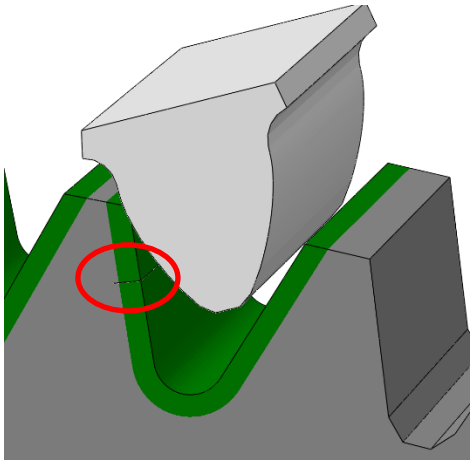
Figure 15. Crack defined in XFEM.

It is of interest to determine the response when the postulated crack is located 13 mm from the top land (corresponding to the lower point of contact during motion) and the extreme torque is applied. The crack shown in Figure 15 is defined using the XFEM capabilities in Abaqus. The distribution of the stress intensity factor along the crack front is presented in Figure 16 for two crack depths penetrating the core material.

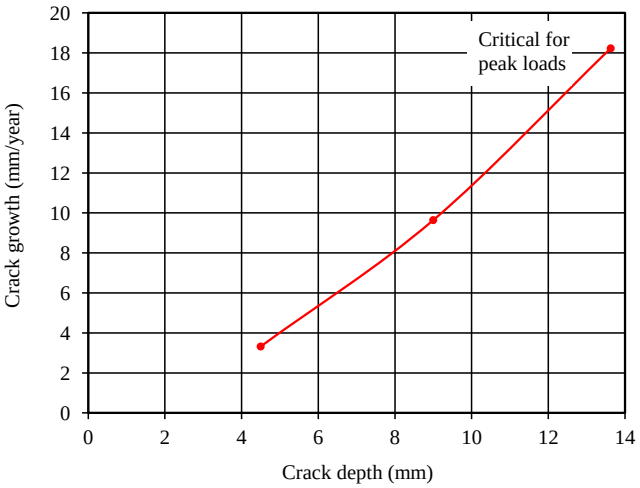
Figure 17. Crack growth.

Maintaining the assumption of a linear relation in log scales between the peek stress intensity factor and the crack depth, Figure 17 shows the crack growth up to the critical depth. The critical depth would be 13.6 mm for extreme loads. This result is somewhat sensitive: if toughness were 1483 MPa$\sqrt{\text{mm}}$, failure would be expected after a depth of 4.5 mm; the same would occur if the load were 91 kNm. This torque, however, is unable to produce enough yielding for the bending failure of an unimpaired tooth. Starting from a 4.5 mm crack in the lower flank, the critical depth would be reached in about 2 years.
