Analysis of Pressure Transients and Cavitation in a Distributor

Patricia González, Javier Rodríguez, Joaquín Martí, and Francisco Martínez

Principia, Velázquez 94, 28006 Madrid, Spain

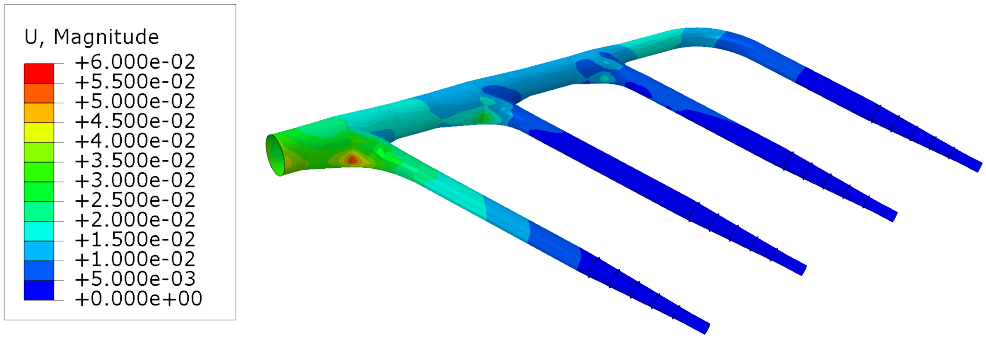
Figure 6. Displacements under pressure of 6.26 MPa (m).

Before analysing the transient response of the distributor to the dynamic excitation generated by the accident, it is necessary to arrive numerically at the initial conditions that existed prior to the accident. This analysis was carried out by slowly applying a pressure of 6.26 MPa in the water contained in the distributor to ensure that an essentially static configuration had been achieved prior to starting the analysis of the transient. The resulting displacement amplitudes are shown in Figure 6 and the von Mises stresses in the steel structure are plotted in Figure 7.

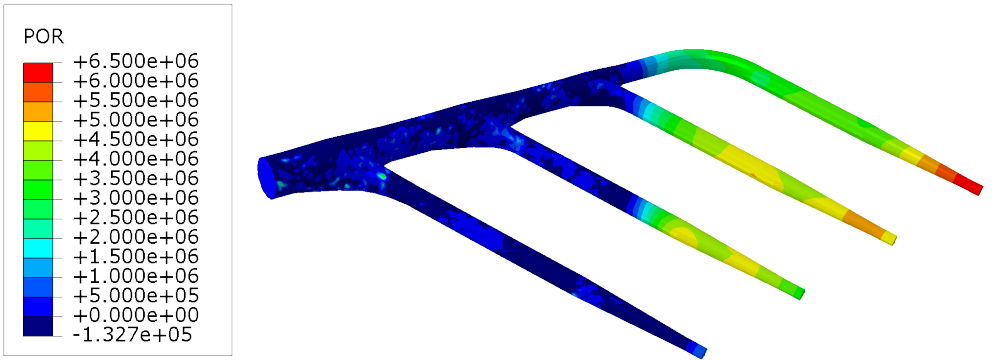
Figure 8. Pressure after 50 ms (Pa).

Figure 8 shows the water pressures 50 ms after the onset of the accident. The depressurisation of the water can be seen to extend to different points along all four legs of the distributor. The stresses generated in the distributor at that same time appear in Figure 9; they already show the first consequences of bending of the four legs, with their final 6 m fixed.

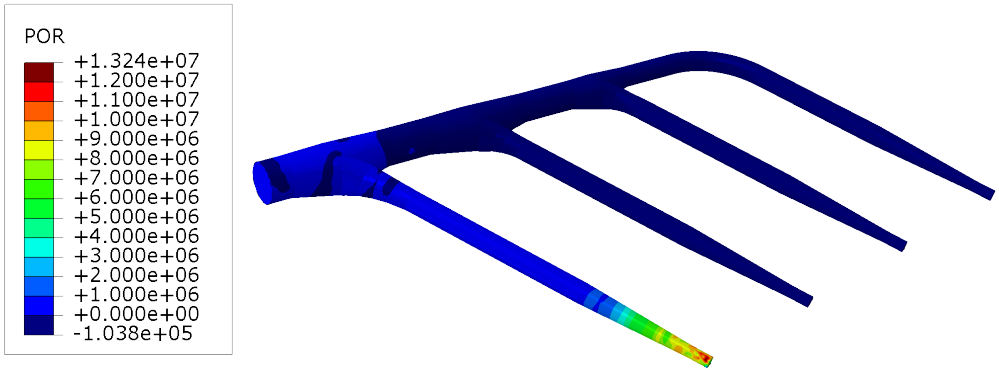
Figure 10. Pressures after first implosion at 4.8 s (Pa).

The latter is the first phenomenon to occur, as the water column hits F7, the end of the first leg of the distributor, 4.8 s after the onset of the incident. The water pressures at that point, shown in Figure 10, clearly evince this event; the associated stresses in the distributor appear in Figure 11.

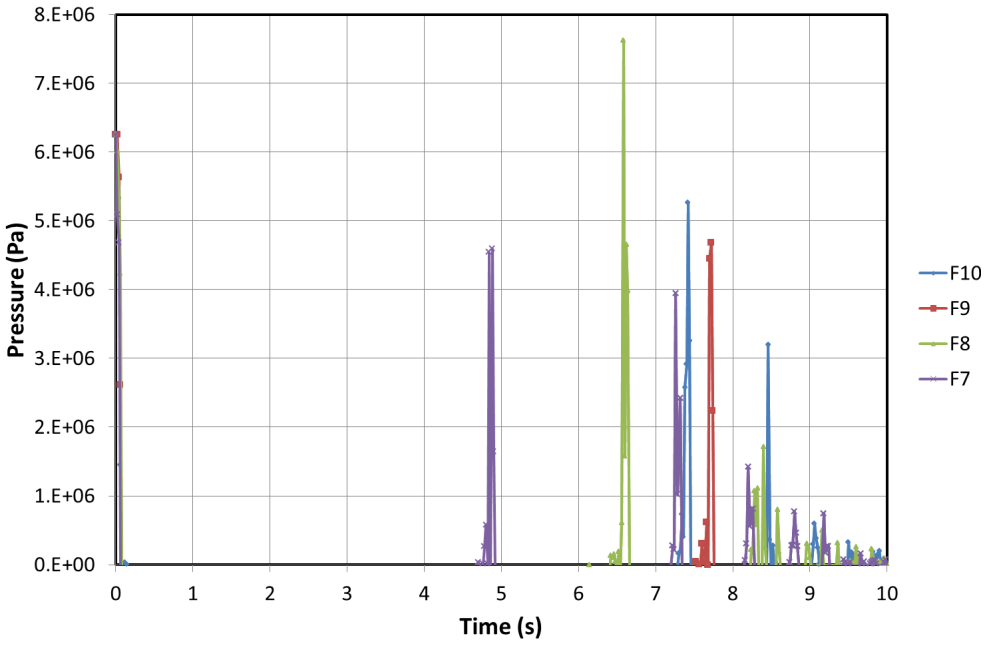
Figure 12. Pressure histories over the first 10 s.

The sequence described earlier is repeatedly indicated in Figure 12, which presents the pressure histories at the end points of the four legs of the distributor. As already mentioned the first spike shown corresponds to the collapse of the vapour bubble at F7 at 4.8 s; the corresponding spikes at the other leg ends can be seen to follow.

The peak pressures developed during the transient only exceed 12 MPa at the end of the first distributor leg; those pressures arise around 4.8 s after the onset of the accident.

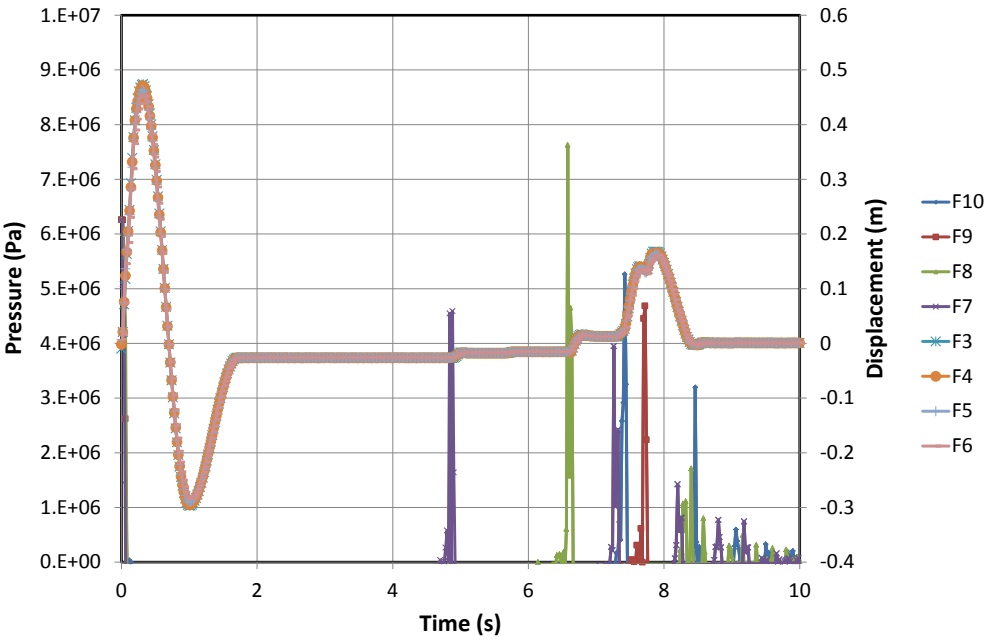
Figure 13. Superposition of pressure and displacement histories.

A particularly illustrative plot is perhaps that provided by Figure 13, where the pressure and displacement plots are superimposed. It clearly confirms that the various displacement jumps are caused either by the initial incident or by the subsequent implosions of collapsing vapour bubbles. In this figure there is no relation between the origins of the two ordinates plotted together.

It is also of interest to observe the displacements at the plateaus in the displacement histories that appeared in Figure 13. The maximum displacements at those times turn out to be only on the order of very few cm or less, which indicates that, following the transient displacements, the distributor essentially returns to its original location, as the vibrations triggered by the accident activate a largely elastic response.

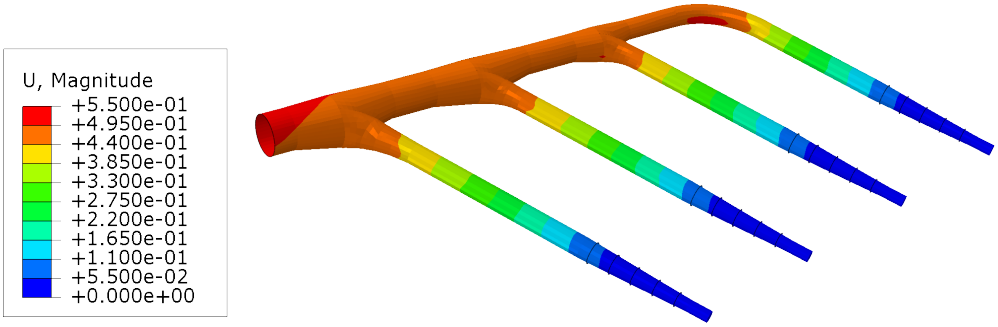
Figure 14. Displacement magnitudes after 0.3s (m).

The largest component of the displacement is transverse to the direction of the four distributor legs and the maximum value occurs 0.3 s after the onset of the accident. This time has therefore been selected for showing the displacement magnitudes (Figure 14), which are on the region of 50 cm for all the main stretch of the distributor. The displacements peak again, this time in the opposite sense, when the time reaches 1 s.

The peak displacements occur during the first cycle of response, 0.3 s after the onset of the accident, and attain values on the region of 50 cm. The peak values would grow by about 10% if the distributor is assumed to rest on frictionless supports, rather than with the friction coefficient of 0.15 employed here.

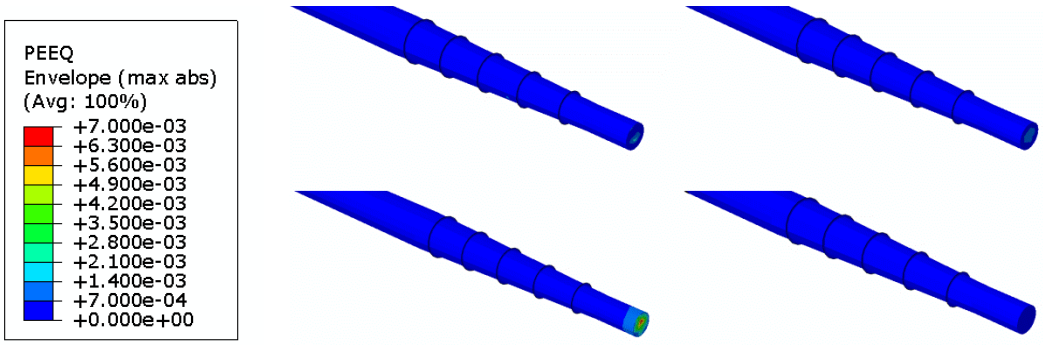
Figure 15. Accumulated plastic strains (-).

Along that same line of thought, any damage caused to the distributor would be manifested in plastic strains accumulated during the transient event. The analysis shows that the only points where plastic strains develop are the ends of the four legs of the distributor and, as observed in Figure 15, they are all below 0.7%. Taking all this information into account, it must be concluded that the distributor did not undergo any enduring damage during the accident.

The plastic strains accumulated during the transient are limited to the final plugs of the four legs of the distributor and their values are below 1%. If the supports were frictionless plastic strains appear at other locations, but their values are well below 1%.

As a consequence of the foregoing observations it is concluded that, at least from a purely structural standpoint, the distributor must be considered to remain sound in its present state. However this may not cover other functionality requirements imposed on the distributor.

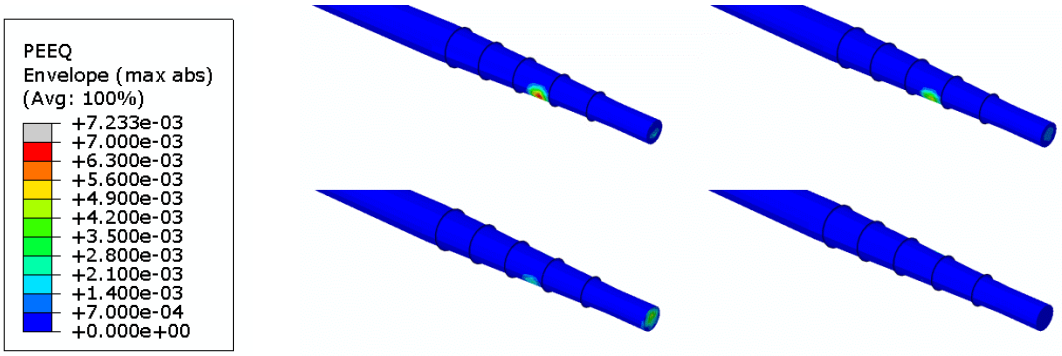
Figure 16. Accumulated plastic strains with frictionless supports (-).

Finally, since 0.15 seemed to be a high friction coefficient for a PTFE interface, the calculations were repeated on the assumption of a frictionless contact. In this situation Figure 16 shows the plastic strains at the ends of the four legs, which remain very small, though they are no longer limited to the final plugs of the distributor legs.

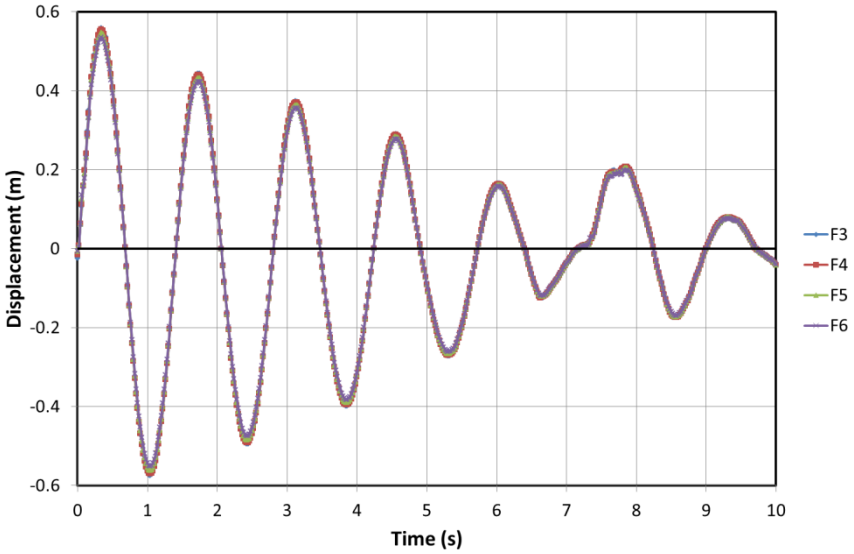
Figure 17. Displacement histories with frictionless supports.

Also, the displacement histories presented in Figure 17 indicate that the peak displacements increase by about 10% with respect to the values attained with a friction coefficient of 0.15 and that, as there is no longer any energy dissipation by friction, the displacements oscillate about the equilibrium position in a more gradual way. Since no material damping had been introduced in the calculations, the decreasing displacements are caused by energy exchanges between the steel and the water, not by material damping.
